The Tender.

For the County class a new design of tender was produced. Its style was reminiscent of the L.M.S., especially below the running plate. The tank was of welded construction with slab sides, whose lines reflected those of the standard G.W.R., Collett 4000 gallon pattern. The design did not meet with the whole-hearted approval of G.W.R. enginemen, notably the locker doors!

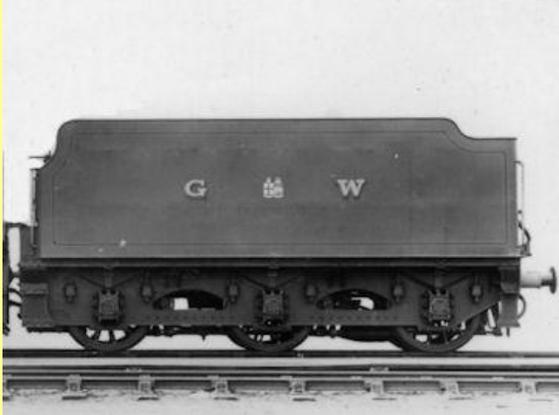
Hawksworth tender for County as built in 1945. (Terry McCarthy Collection).

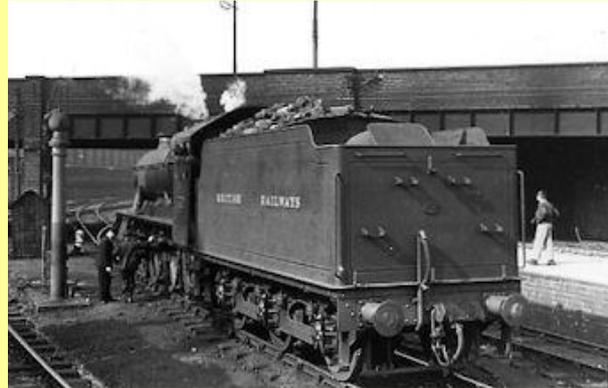
Rear view of County tender - 1016 'County of Hants', Wolverhampton Low Level, 18/09/1948. (Courtesy M. Whitehouse Collection).

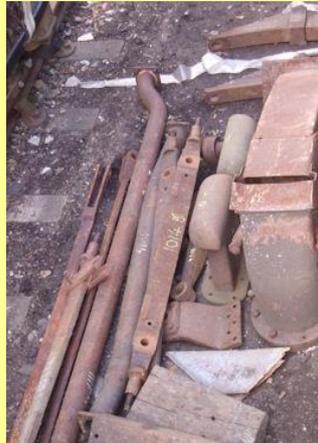
February 2008 - Some of the parts 'harvested' from the Collett tender allocated to the Project. Bits shown include - water scoop equipment, tender air vents, brake rods, steps, springs. etc.

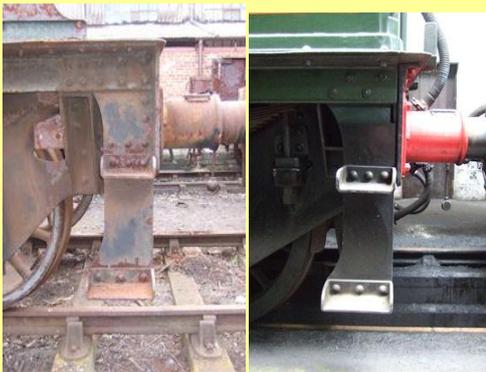
Comparison - Collett tender steps and those on a Hawksworth tender - compatible, thus useful for new-build.

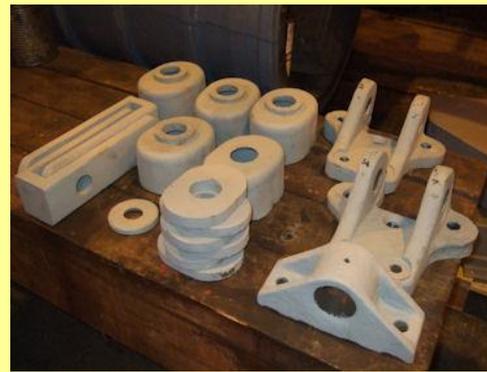
19/04/08- Various restored and primed small parts for the tender - items shown for brake and spring structures.

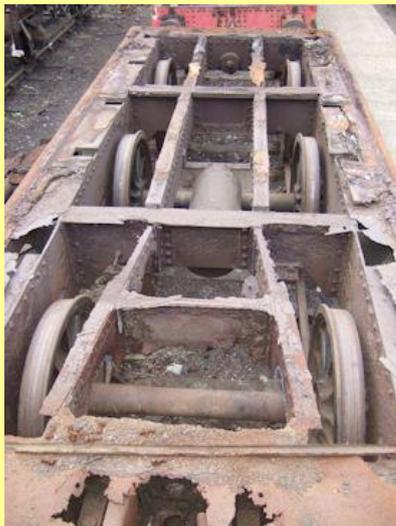
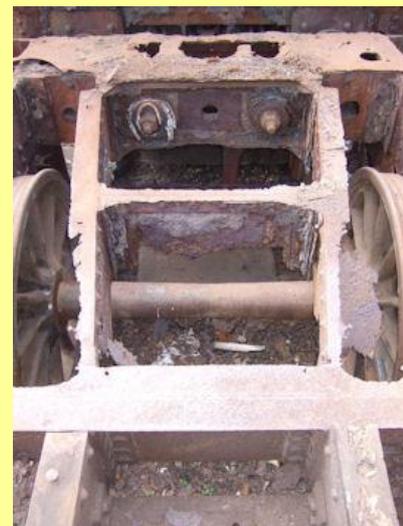
07/06/08 - Collett tender frames revealed following lift of tender body. Items to be reused - wheel sets, horn guides, vacuum-brake cylinder. Likely the longerons to rear usable, as well as two cross members.

14/06/08 - wasted front-end of tender frames - unusable. A clear indication of what 40 years open storage in Barry and Didcot can do to unprotected steel.

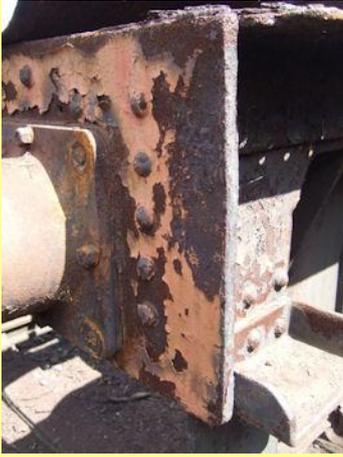
14/06/08 - rear buffer beam - not compatible with County tender, but buffers usable.

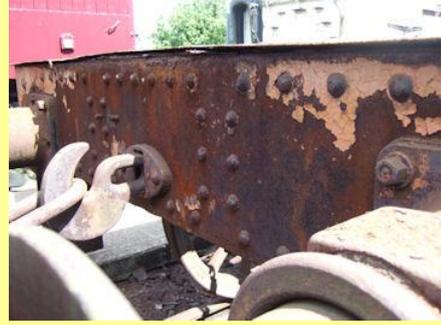
14/06/08 - tender draw hook - usable once extracted.

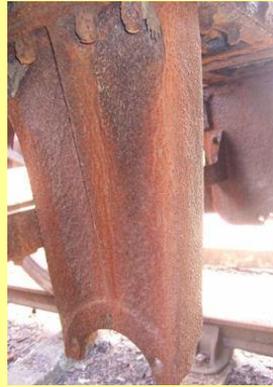
14/06/08 Water scoop bracket - usable.

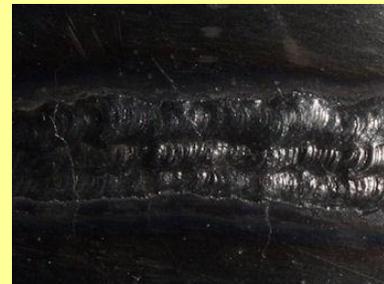
Welding of cracked vacuum-brake cylinder - unsuccessful. As weld and steel forming cylinder cooled, small cracks developed. Likely to require new barrel.

13/12/2008 - weld in vacuum-brake cylinder - note cracks developing in and from weld.

Tender brake cylinder crack repair - 13/12/08 - might be recoverable using a different procedure.

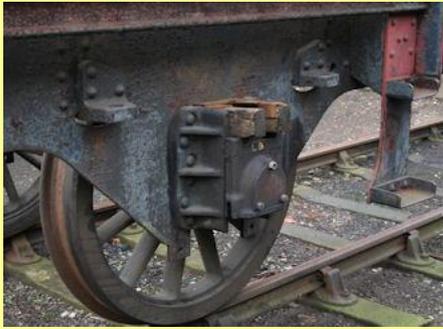
20/12/08 - remains of Collett tender - axle boxes, wheels and steps yet to be removed from carcass. (Terry McCarthy)

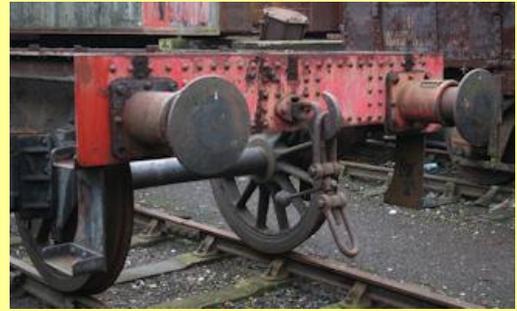
20/12/2008 - Buffers, wheels and draw hook for future use on 1014. (Terry McCarthy)

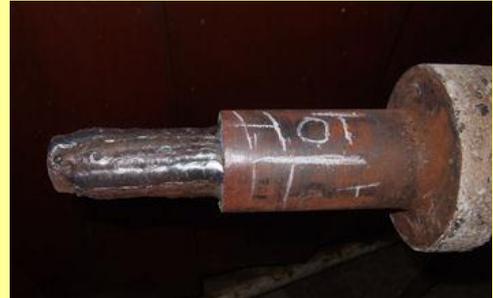
17/01/2009 - Weld built-up on corroded cross beam stub. This will be rethreaded for further use.

Now needs to be rethreaded. Thereafter, all three cross beams to be rebushed.

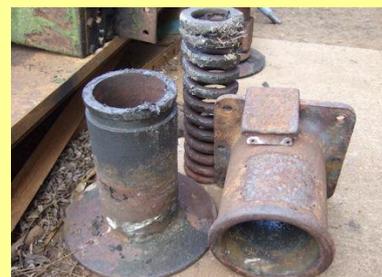
14/03/2009 - buffers dismantled in readiness for cleaning etc.

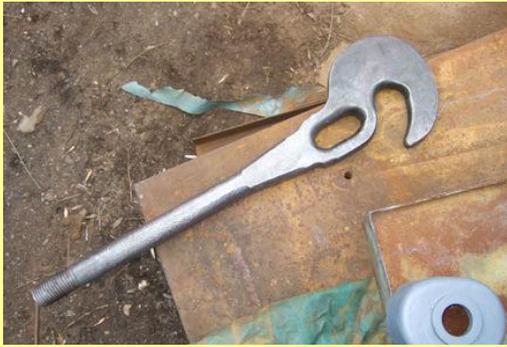
14/03/2009 - tender draw hook - derusted and cleaning ready for painting.

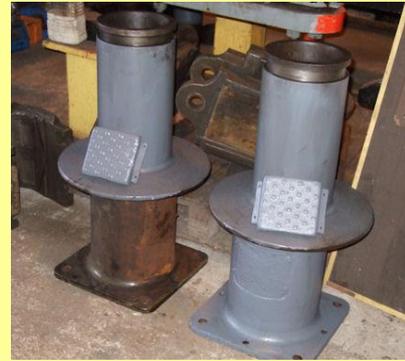
28/03/2009 - Buffers almost finished - only one collar to be primed. Newly manufactured steps prepared for mounting on collar.

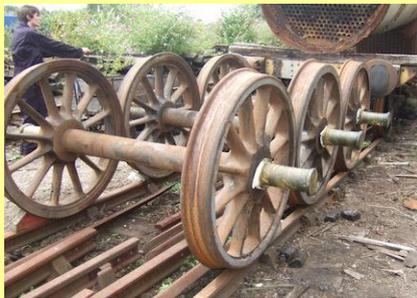
04/07/2009 - Tender wheels released from donor Collett underframe for future use on new Hawksworth tender, standing in the Centre Sidings.

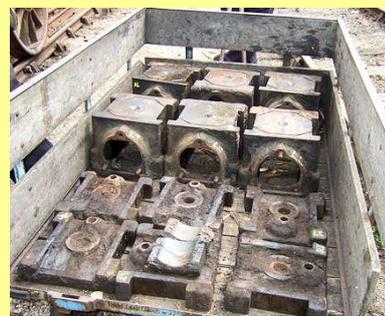
04/07/2009 - axle boxes and top pads removed from tender underframe and transported to shop for cleaning etc.

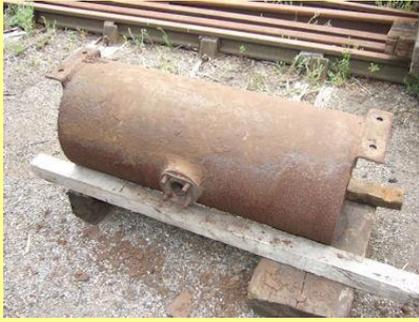
04/07/2009 - Vacuum reservoir removed from frames.

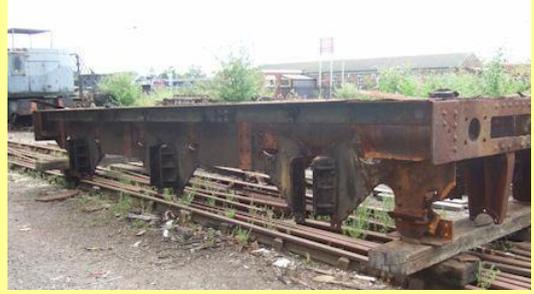
04/07/2009 - Tender frames at Centre Sidings, following lift and removal of most items required for Hawksworth tender reconstruction. Implications of removal of horn glides led to discussions as to the potential use of the frames in another project - removal of horn glides (carefully!) authorised later in the month.

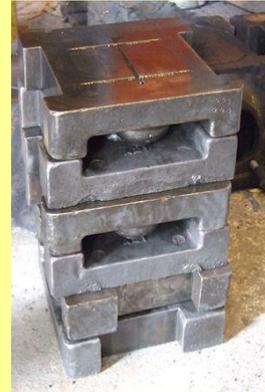
18/07/2009 - axlebox tops after cleaning. Little damage or substantial wear was evident, although the white metal pads will need replacement.

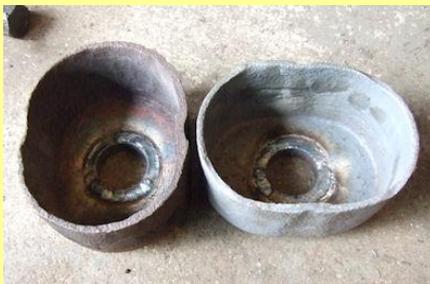
18/07/2009 - Two repaired spring pad retainers. Now have seven out of the twelve required - five to be sought from store or manufactured.

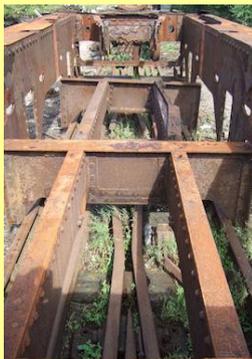
08/08/2009 - stripped tender underframe, focusing upon the central frame.

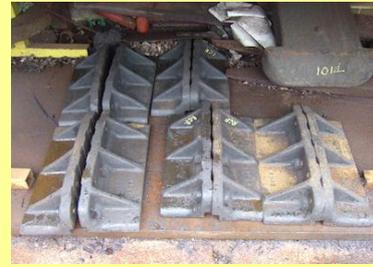
08/08/2009 - Horns laid out after removal from frames, in readiness for examination and cleaning.

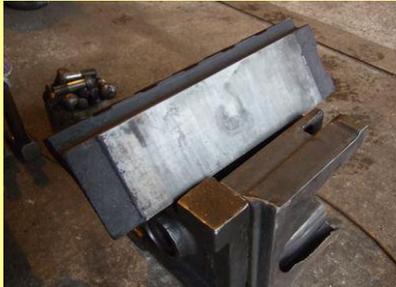
08/08/2009 - Examination of horn wearing faces suggests they are in good order.

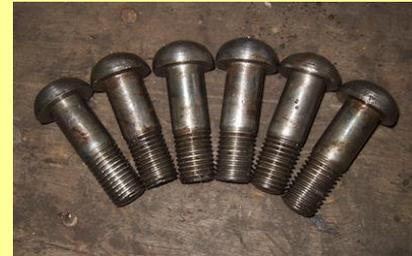
08/08/2009 - some of the 72 horn bolts recovered. All to be cleaned and rethreaded, but are suitable for further use - a large saving! Two will require further attention on the lathe.

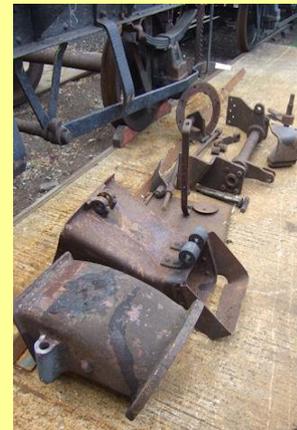
19/09/2009 - Water scoop components laid out in readiness for cleaning etc.

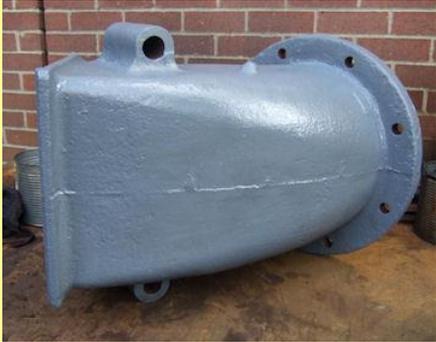
10/10/2009 - Fixed part of water scoop apparatus derusted, cleaned and primed and ready for storage.

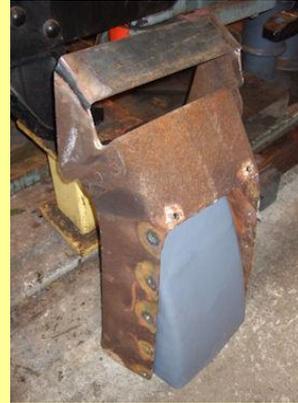
24/10/2009 - Repair to water scoop. Subsequently, completely derusted, cleaned and primed. Support struts and brackets similarly processed.

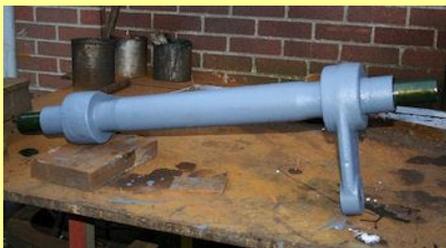
19/12/2009 - water scoop lifting arm, following derusting and priming. *(Terry McCarthy)*

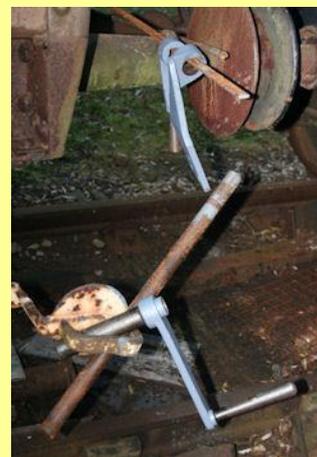
19/12/2009 - tender parts associated with water scoop hanging up to dry - another use for the Pooley Van! *(Terry McCarthy)*

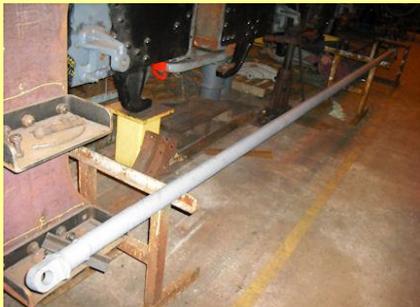
30/01/2010 - water scoop rod, derusted and primed.

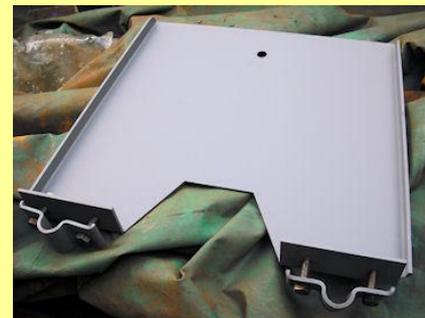
30/01/2010 - newly delivered and primed water scoop plate.

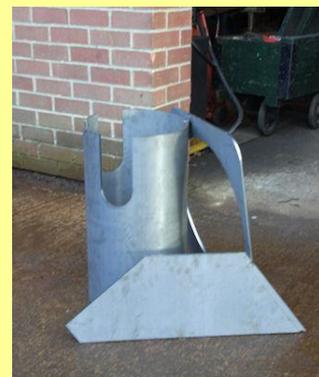
27/02/2010 - newly delivered laser cut steel components for the new-build Hawksworth tender for 1014.

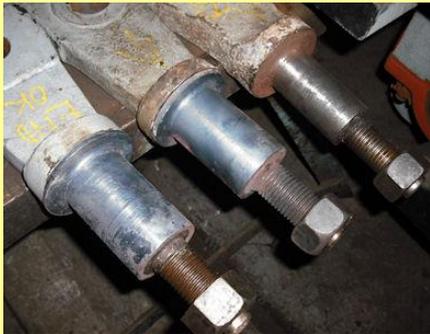
13/02/2010 - completed brake cross-shaft bearings.

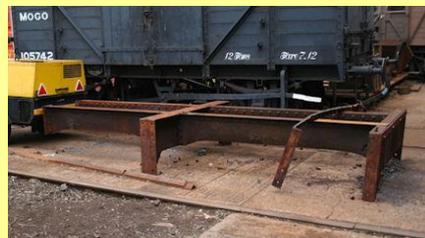
06/05/2010 - Ladder frame from Collett tender being modified to Hawksworth specification. (Terry McCarthy)

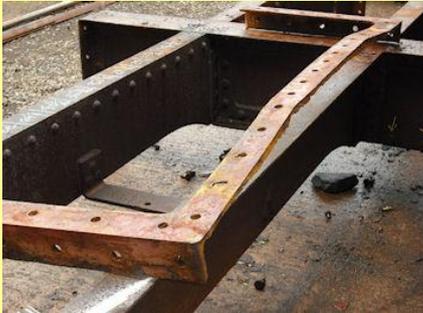
29/05/2010 - old, rusted 'U' shaped angle as removed from underframe.

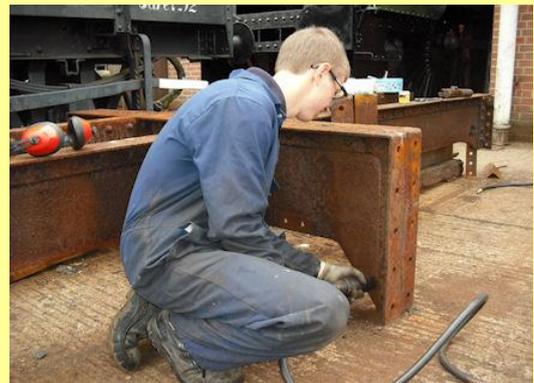
19/06/2010 - A posed illustration of the needle gunning operation - ear defenders would be used in reality.

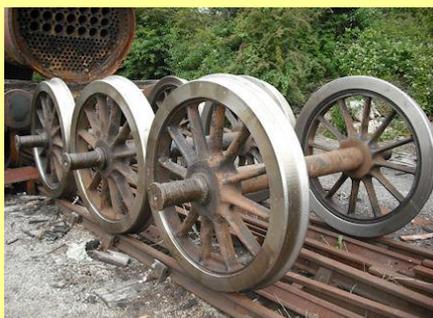
19/06/2010 - tender wheel set - new steel tyres fitted.

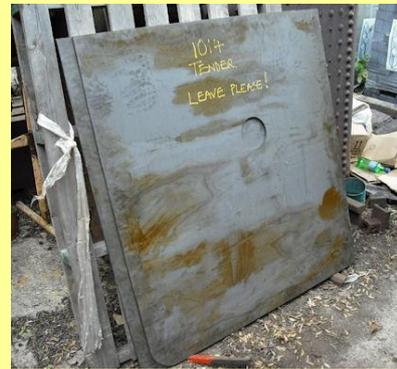
31/07/2010 - steel plate for Hawksworth tender base. Latter needs eight such sheets which will be assembled on a flat steel base prior to being moved indoors for the rest of the tender to be built on it.

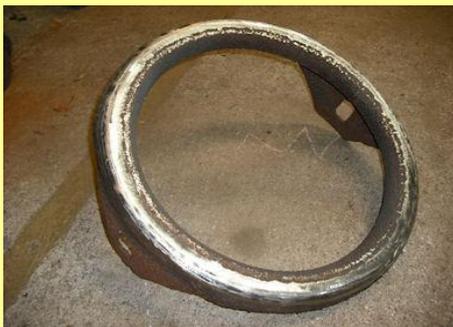
31/07/2010 - Ring for the tender box filter sand blasted clean

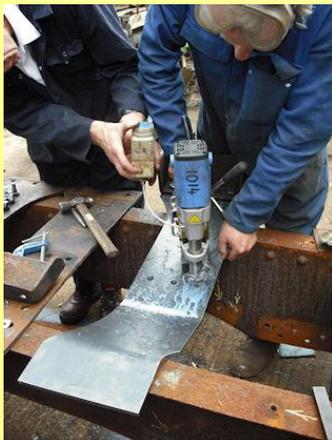
31/07/2010 - Previously shaped rear steps back plate being drilled to take the steps harvested from the Collett tender.

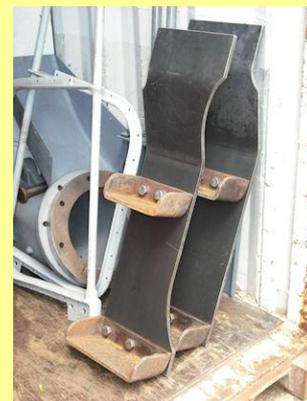
31/07/2010 - Completed steps. Steps temporarily bolted to back plate - to be riveted during Work Week.

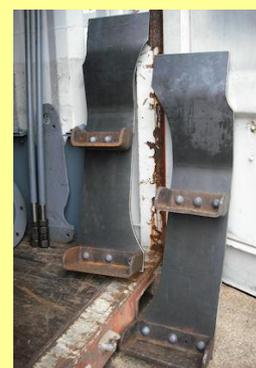
06/08/2010 - Rear tender steps - steps riveted to the backplate.

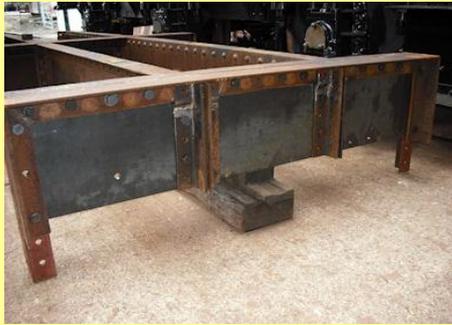
06/08/2010 - sandwich plates riveted to the tender ladder.

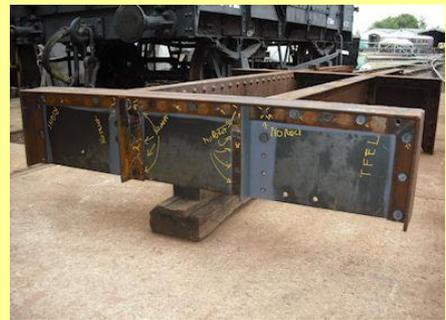
06/08/2010 - riveting on tender ladder frame.

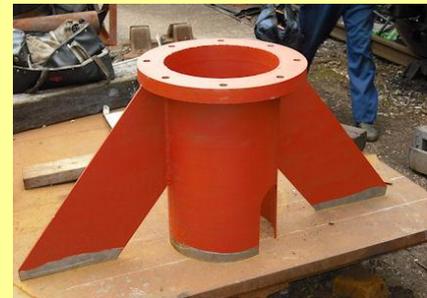
21/08/2010 - Completed water scoop support tube.

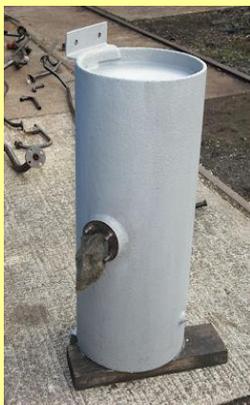
25/09/2010 - Vacuum reservoir or cylinder following reconditioning.

Vacuum reservoir/cylinder examined and deemed repairable. Reconditioning commenced - derusted, studs cleaned and painted in primer. Drain nipple needs to be removed and a replacement fitted.

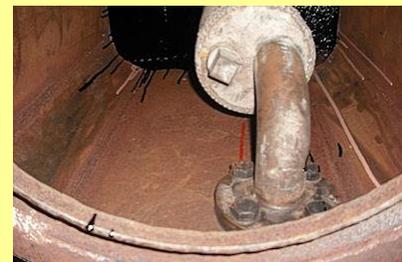
25/09/2010 - Internal view of an installed tender filter (from 4079) showing one of the two filters we are considering updating to a more effective system.

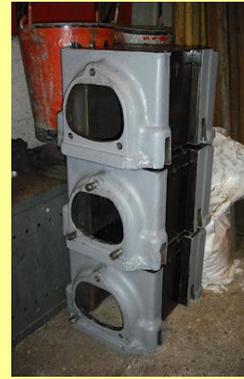
25/09/2010 - Reconditioned axle boxes prior to storage.

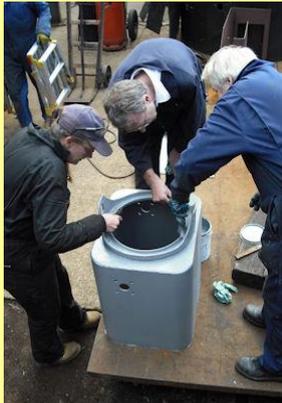
25/09/2010 - Working on the new tender filter box casing.

Tender filter box housing progressing.
Decision required before proceeding further, whether we retain the original specification, or design something more efficient and effective.
